Kinder Morgan Linnton Terminal River Bank Erodability Assessment

PREPARED FOR: Kinder Morgan Liquids Terminals LLC
PREPARED BY: Todd Cotten/CH2M HILL
COPIES: Keith Sheets/CH2M HILL
Eric Aronson/CH2M HILL
Jeff Gentry/CH2M HILL
DATE: November 15, 2010

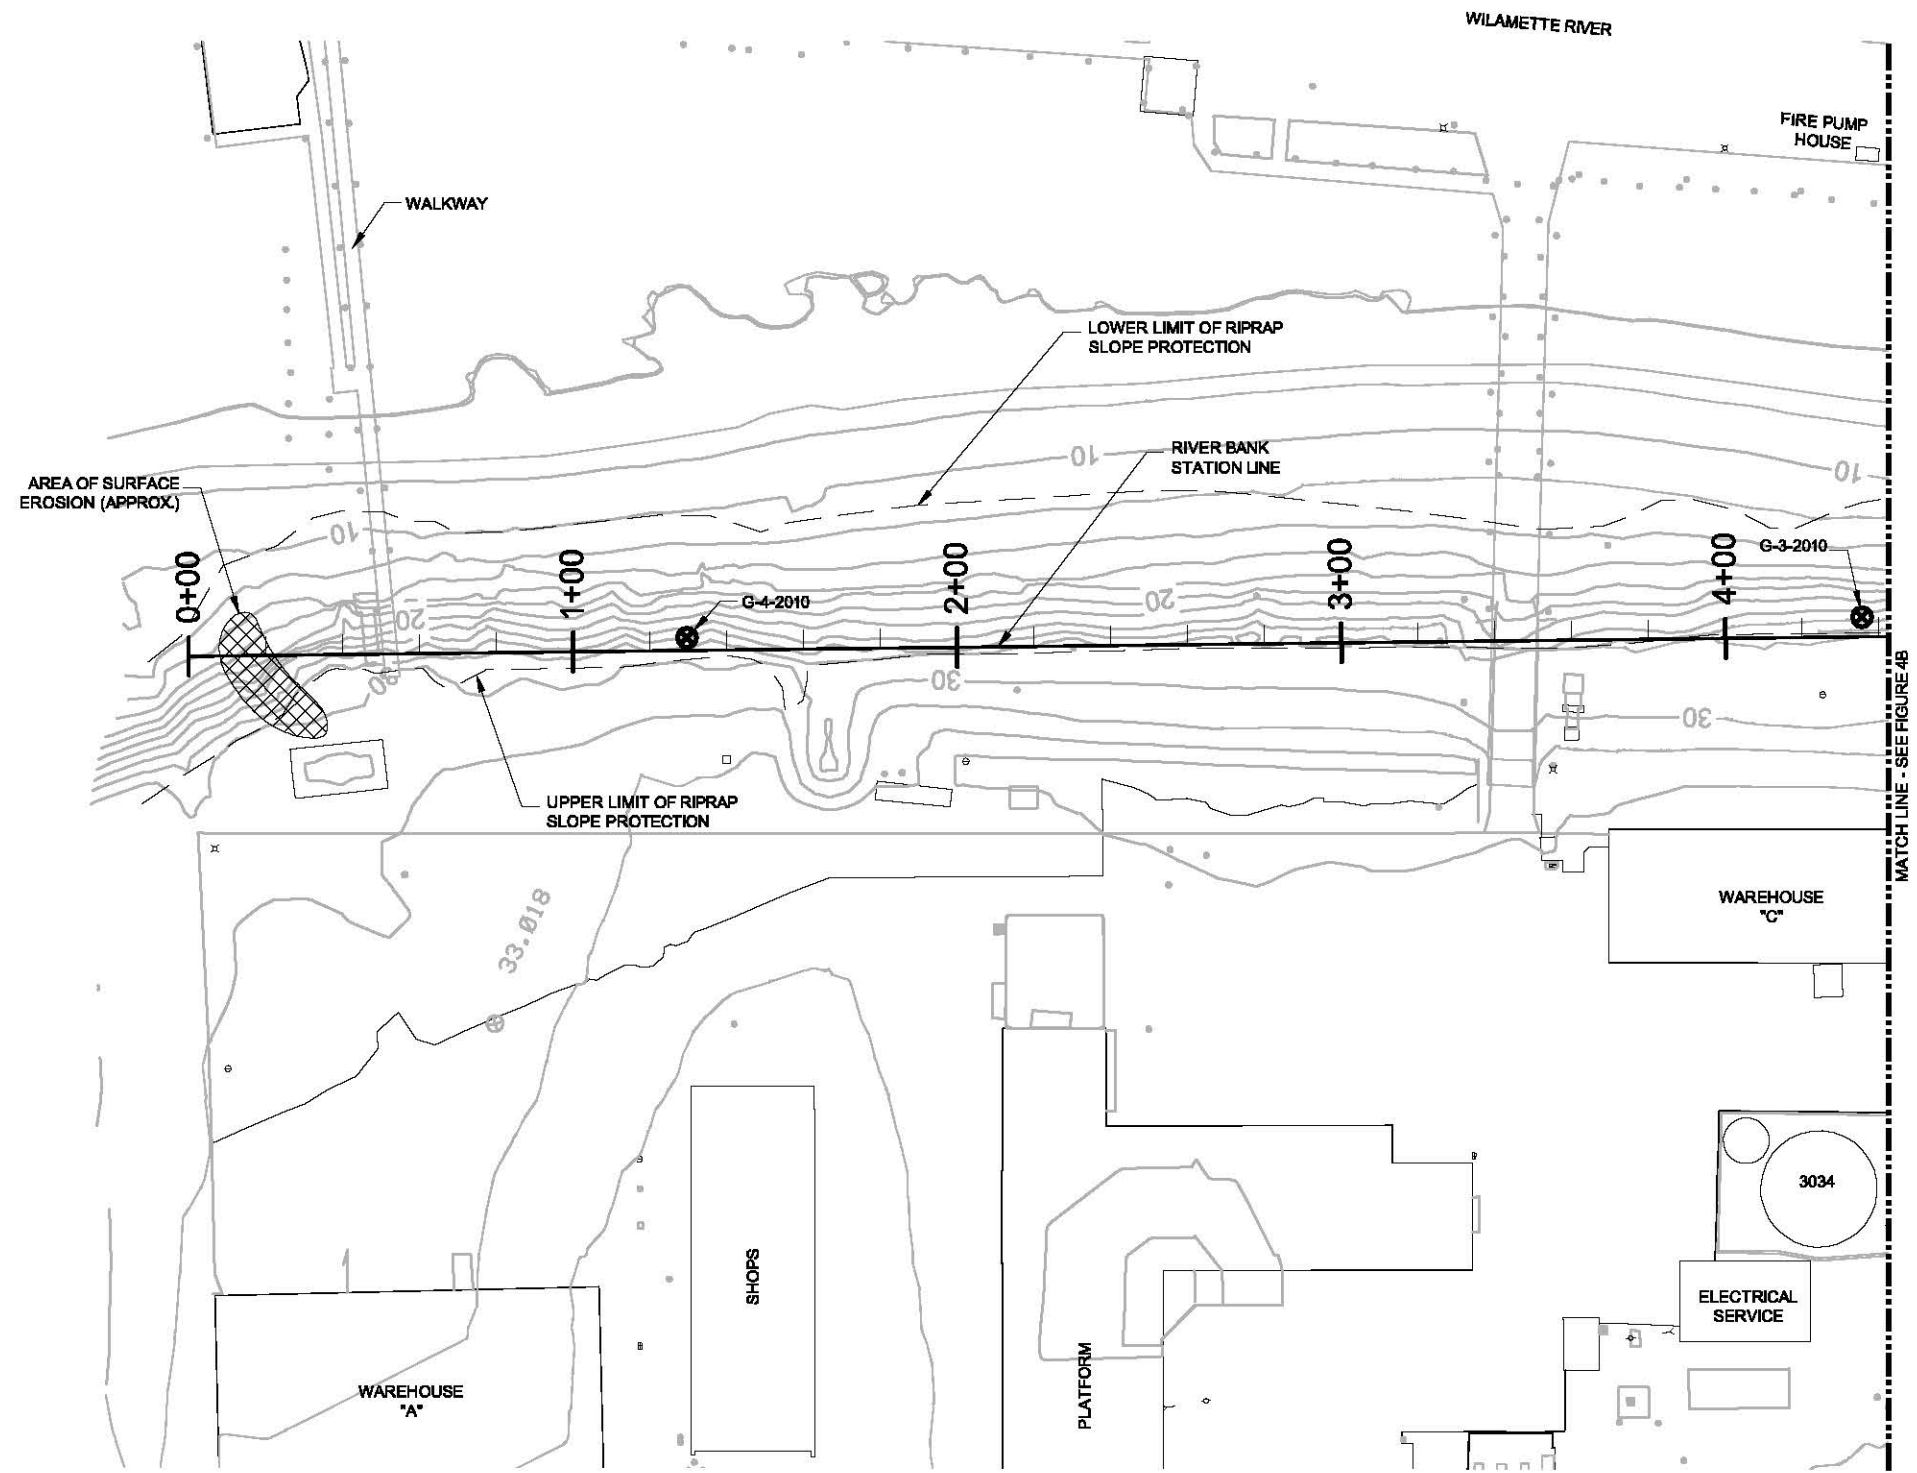
FIGURE 4A
River Bank Sample Locations
Kinder Morgan Liquid Terminals LLC
Linnton Terminal
11400 NW St. Helens Road
Portland, Oregon

There is evidence of minor erosion of the bank in this area from surface water runoff. Surface water appears to collect at the top of the bank and flow around the existing mooring dolphin and over the bank near Station 0+20. The area where signs of surface water erosion was noted is shown in Figure 3.

A bulk sample of bank material was collected for grain-size analyses along the upper portion of the bank at Station 1+30 as shown in Figure 4A. The sample was labeled as G-4-2010.

A bulk sample of bank material was collected for grain-size analyses along the upper portion of the bank at Station 4+35 and shown in Figure 4A. The sample was labeled as G-3-2010.

LOCATION OF OBSERVED EROSION (APPROXIMATE)

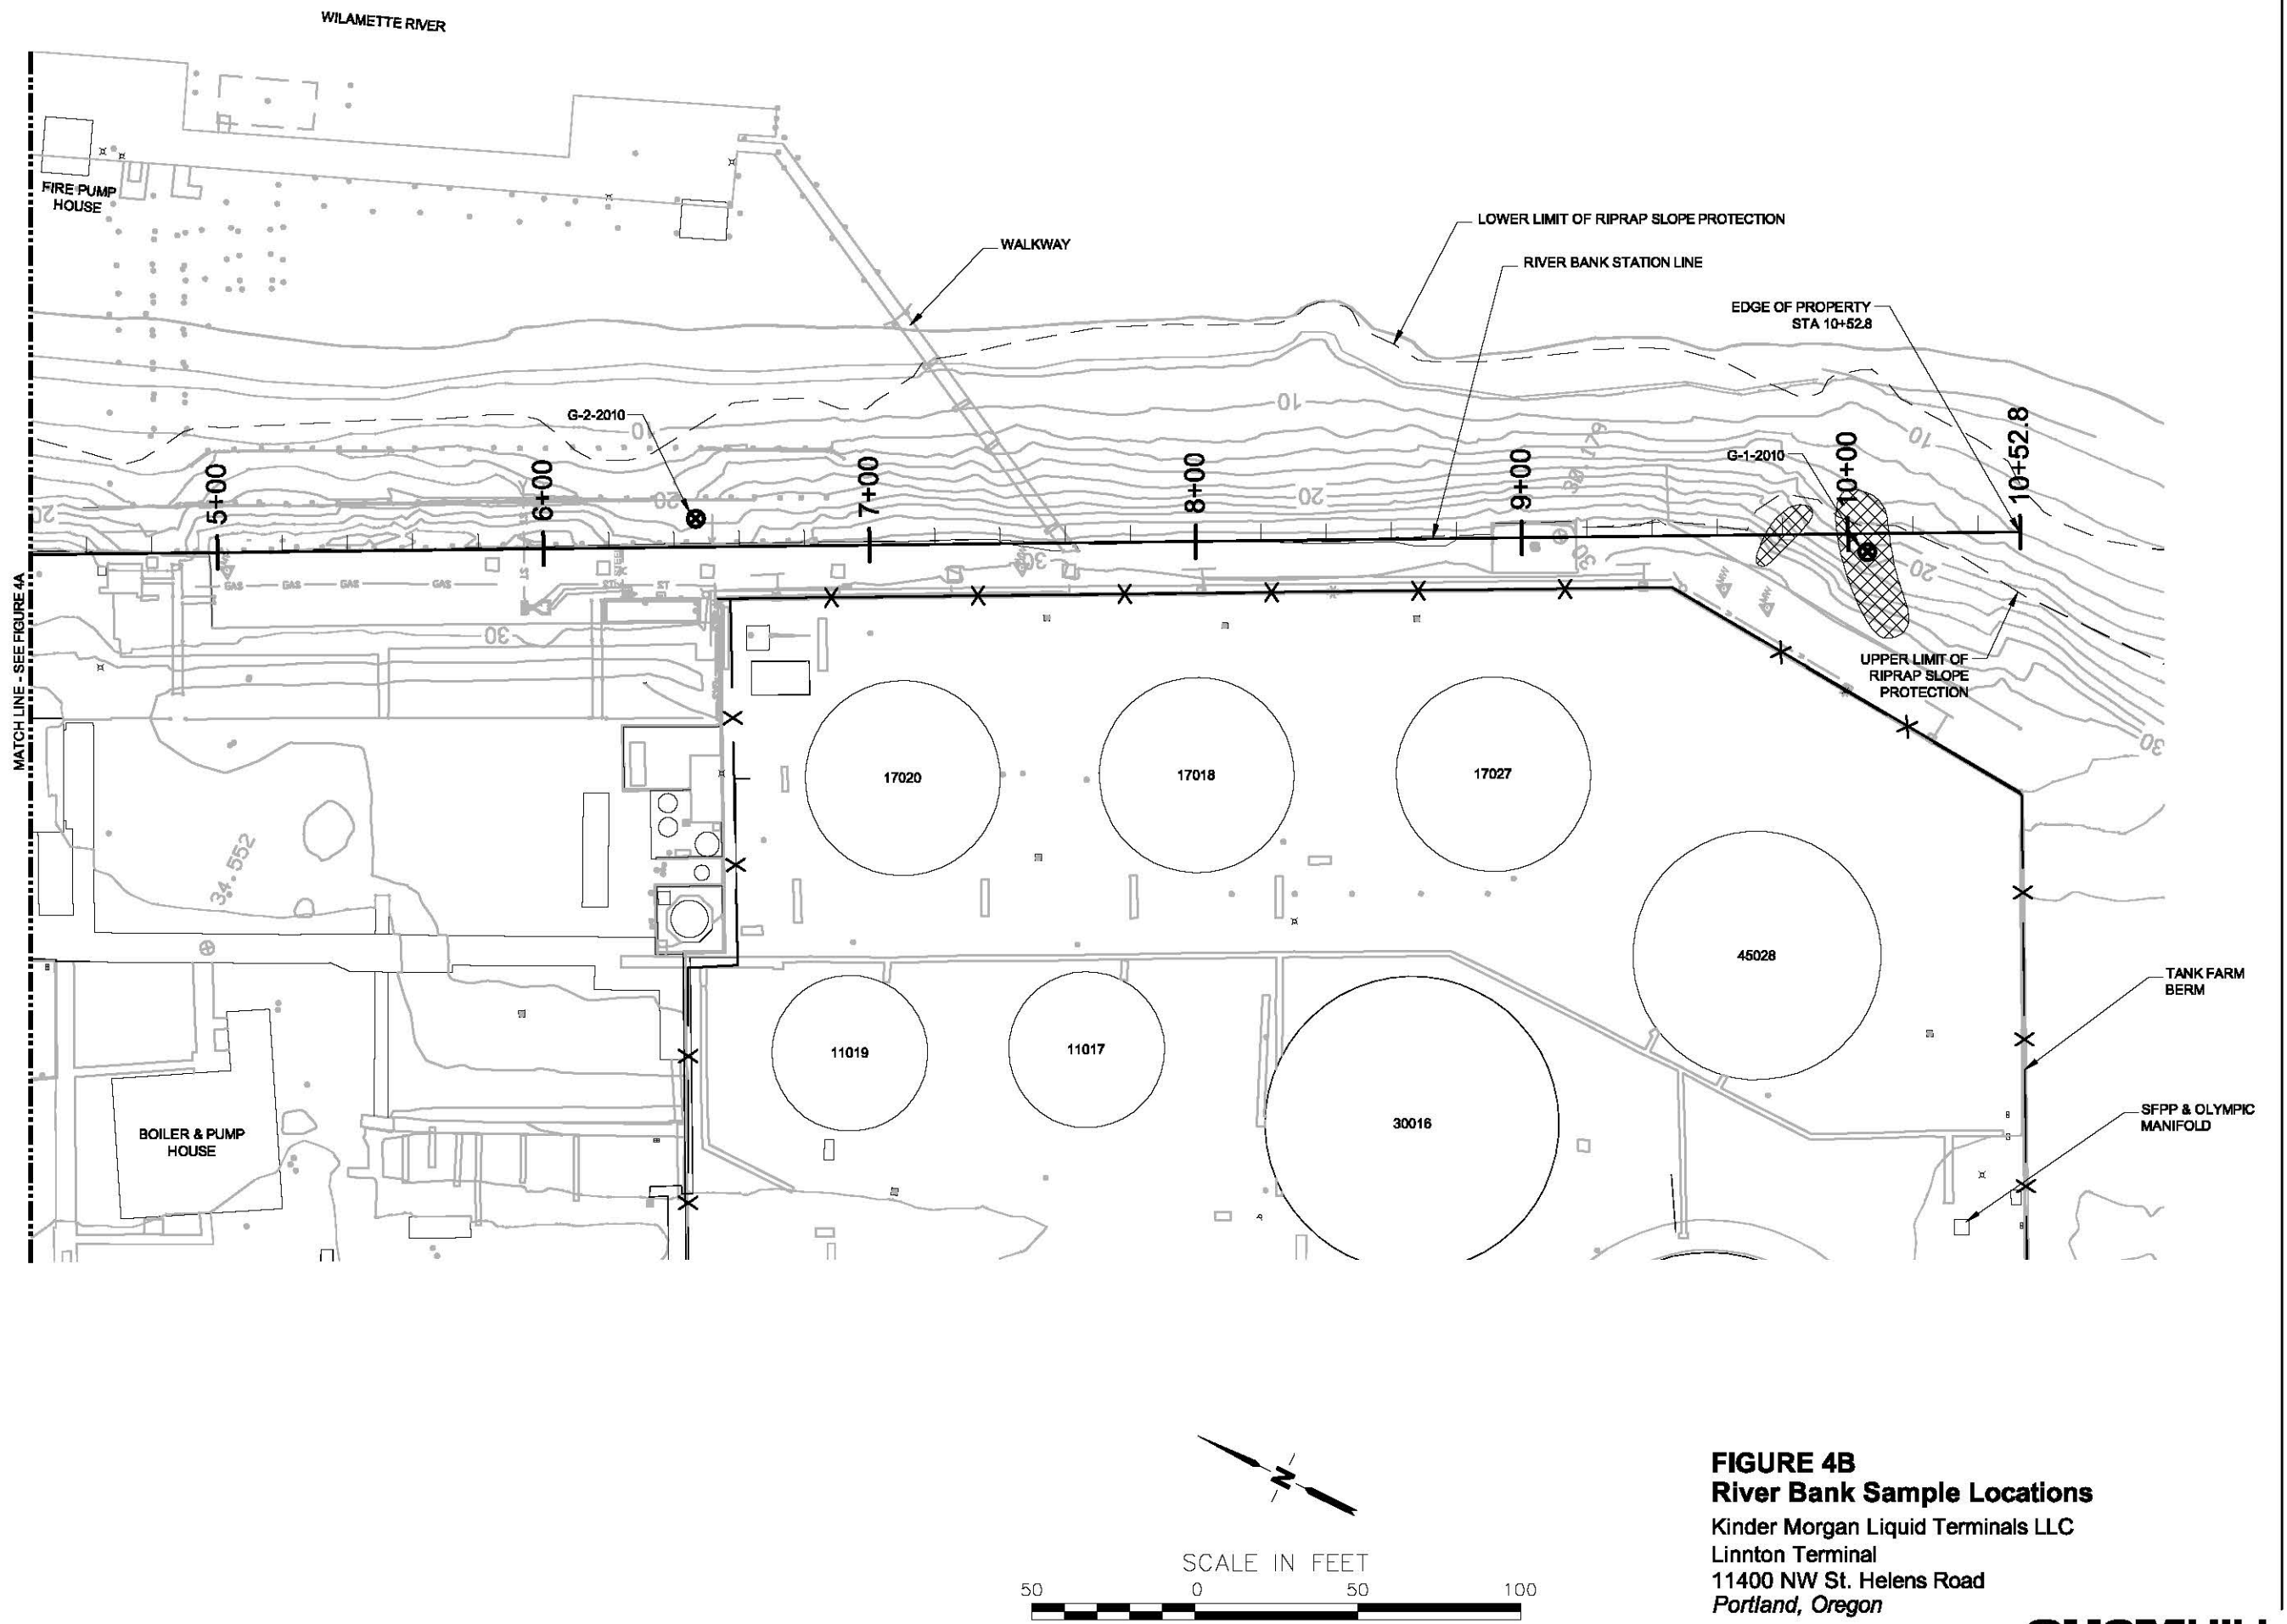
FIGURE 4B
River Bank Sample Locations
Kinder Morgan Liquid Terminals LLC
Linnton Terminal
11400 NW St. Helens Road
Portland, Oregon

There is evidence of minor erosion of the bank in this area from surface water runoff. Surface water appears to collect at the top of the bank and flow down the bank near Station 10+00. The area where signs of surface water erosion were observed is shown in Figure 3.

A bulk sample of bank material was collected for grain-size analyses along the upper portion of the bank near Station 10+05 as shown in Figure 4B. The sample was labeled as G-1-2010.

**LOCATION OF OBSERVED EROSION (APPROXIMATE)**

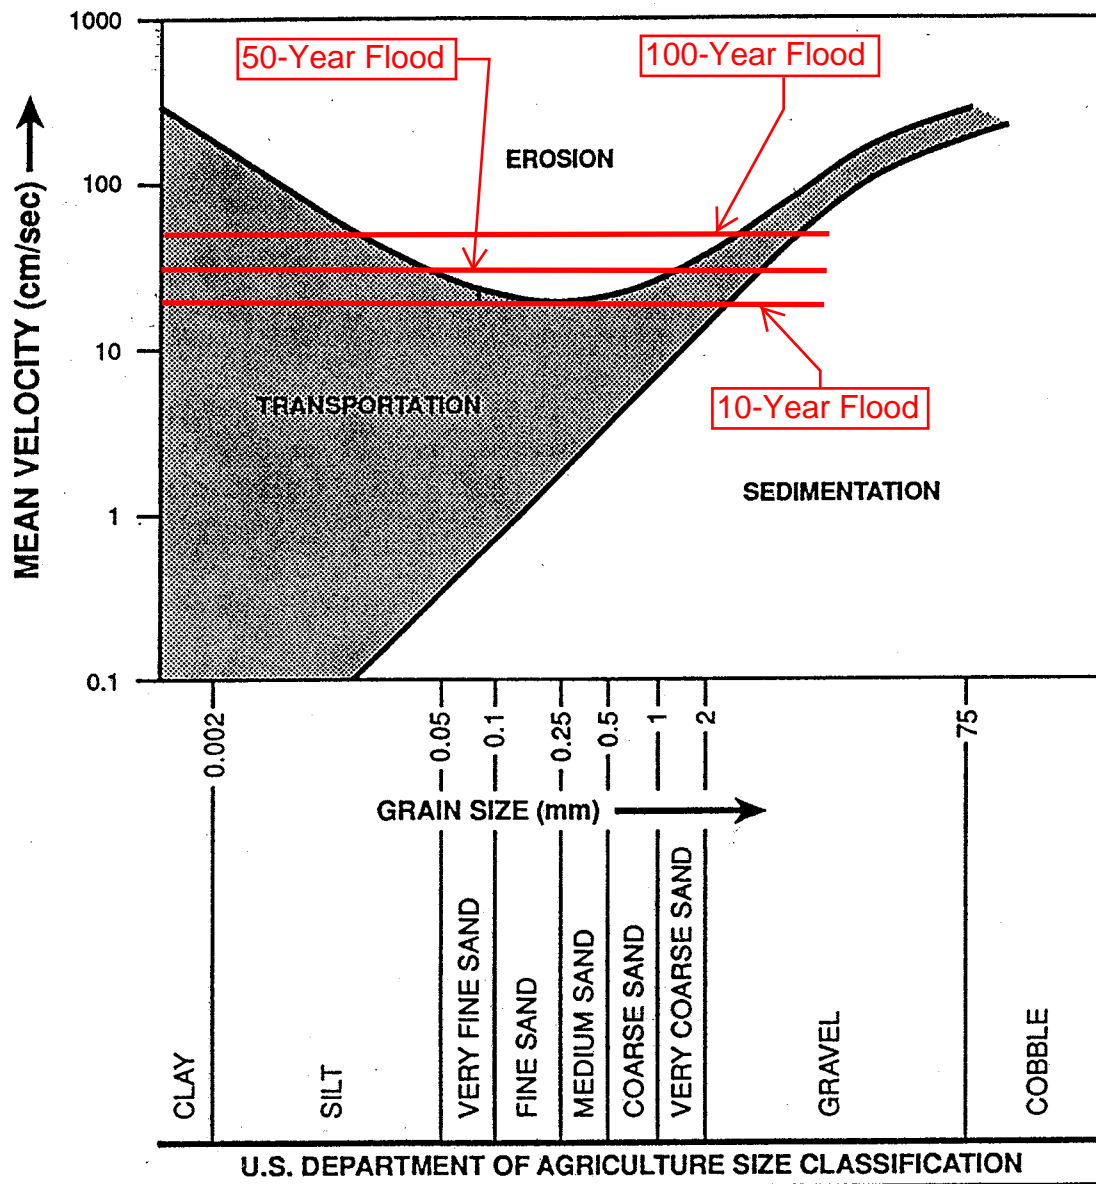
FIGURE 5
SEDIMENT TRANSPORT REGIMES
BASED ON THE HJULSTRÖM DIAGRAM

Stream velocities for the 10-, 50-, and 100-year flood events are plotted on the Hjulström Diagram in Figure 5. This diagram shows a plot of grain size versus mean water velocity for the sedimentation, transportation, and erosion of non-cohesive sediments. The diagram was developed based on current speeds 1-meter above the sediment bed, but provides approximate grain sizes that will be transported using the river current velocities discussed herein. Figure 5 suggests that erosion of even fine-grained bank soil due to river currents is not anticipated for less than the 10-year flood event. For the 100-year flood event, bank material consisting of coarse sand/very fine gravel to silt may be subject to erosion. On the bases of these results, the potential for river bank erosion due to river currents appears to be low except for flood events greater than the 50-year event.

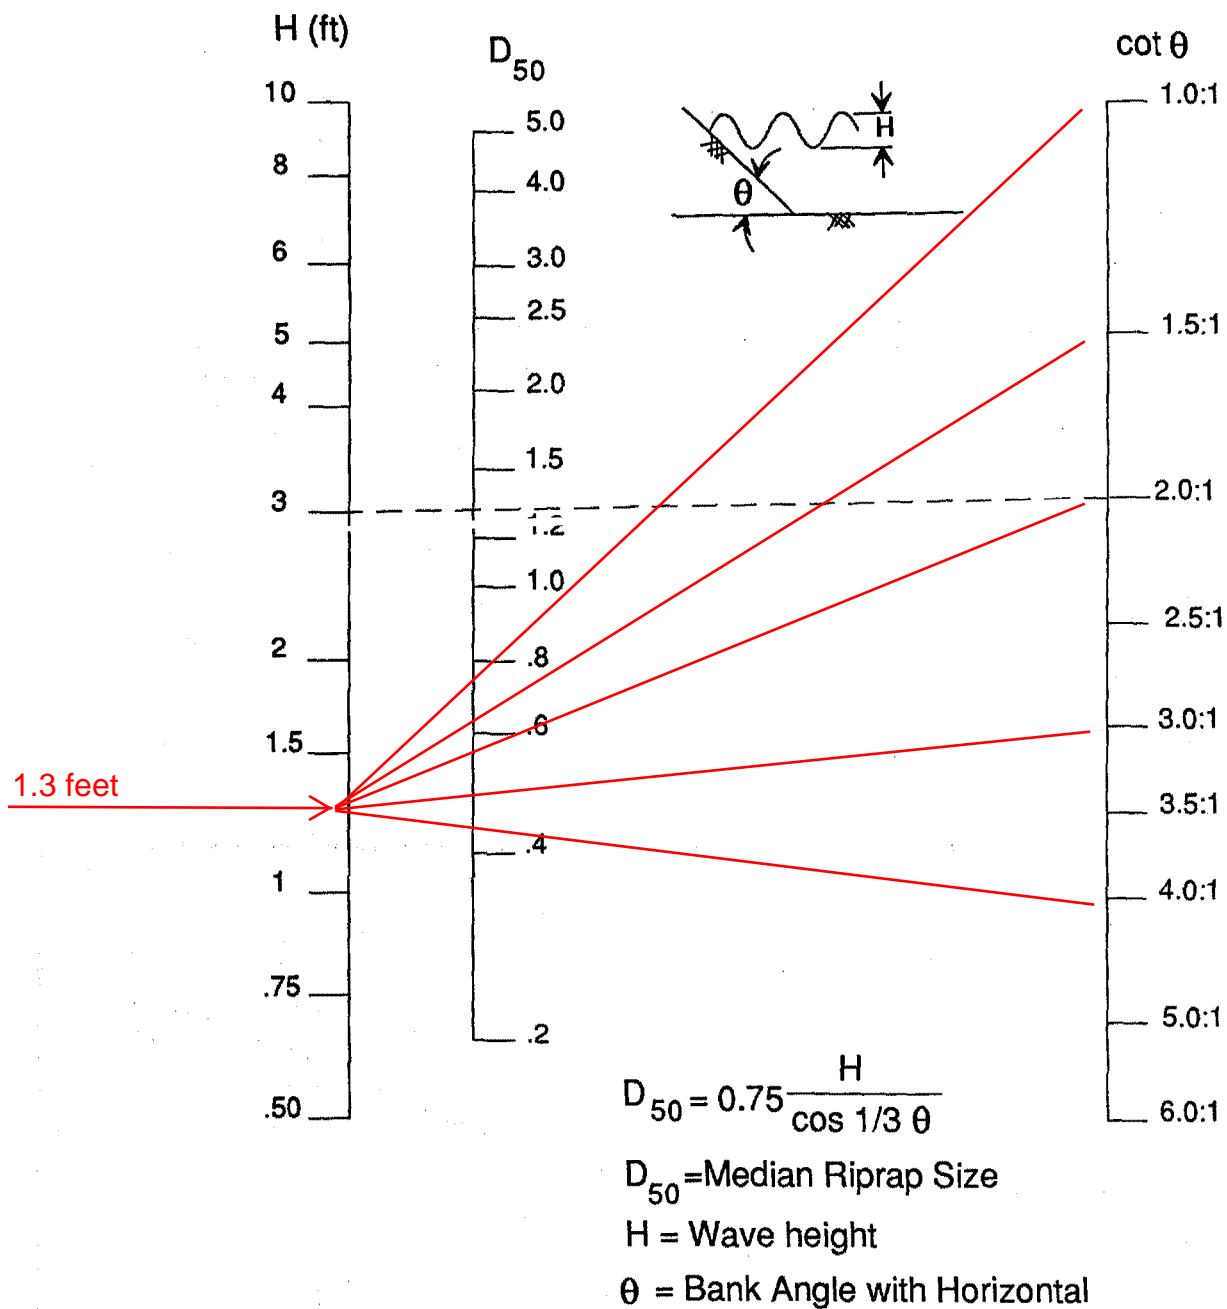
Chart 7. Hudson relationship for riprap size required to resist wave erosion

A nomograph showing the results of this equation is provided in Figure 7. As shown on the figure, the required median size of riprap needed to withstand erosive forces due to wind generated waves having a height of 1.3 feet would be about 0.45, 0.50, 0.58, and 0.75 feet diameter for bank slopes of 4H:1V, 3H:1V, 2H:1V, and 1H:1V, respectively. Using a specific weight of 2.65 for the stone, these stone dimensions are equivalent to median riprap weights of about 9, 12, 20, and 40 pounds.

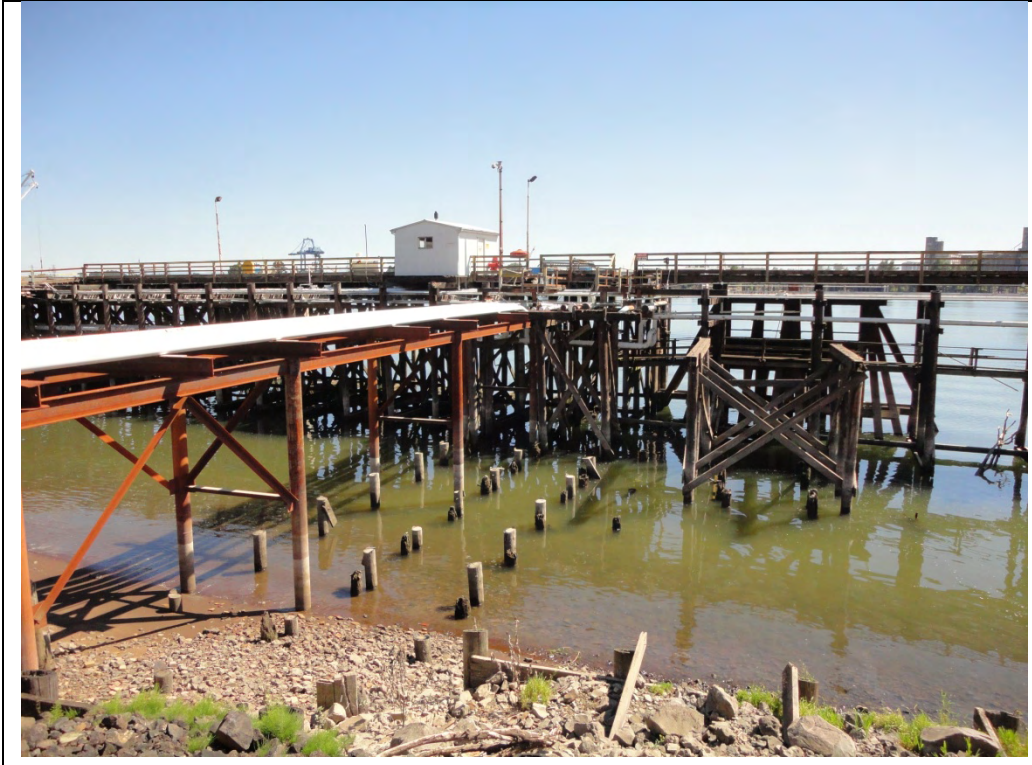
dock and associated walkways are founded on timber pile and extend from near the northern end of the property for more than 700 feet to the south. Typically the timber pile foundations consists of at least two rows of piles running parallel to the shore, but in some areas up to five rows of piles are present. The timber piling associated with the dock structure act to break up boat and wind generated waves that originate on the river and help to protect about two-thirds of the river bank. The protection is greatest in the areas that include the highest concentration of piling. Pictures of the existing dock structure are shown in Photographs 1 and 2 in Appendix A.

Photograph 1: Dock structure looking east from approximate Station 5+20

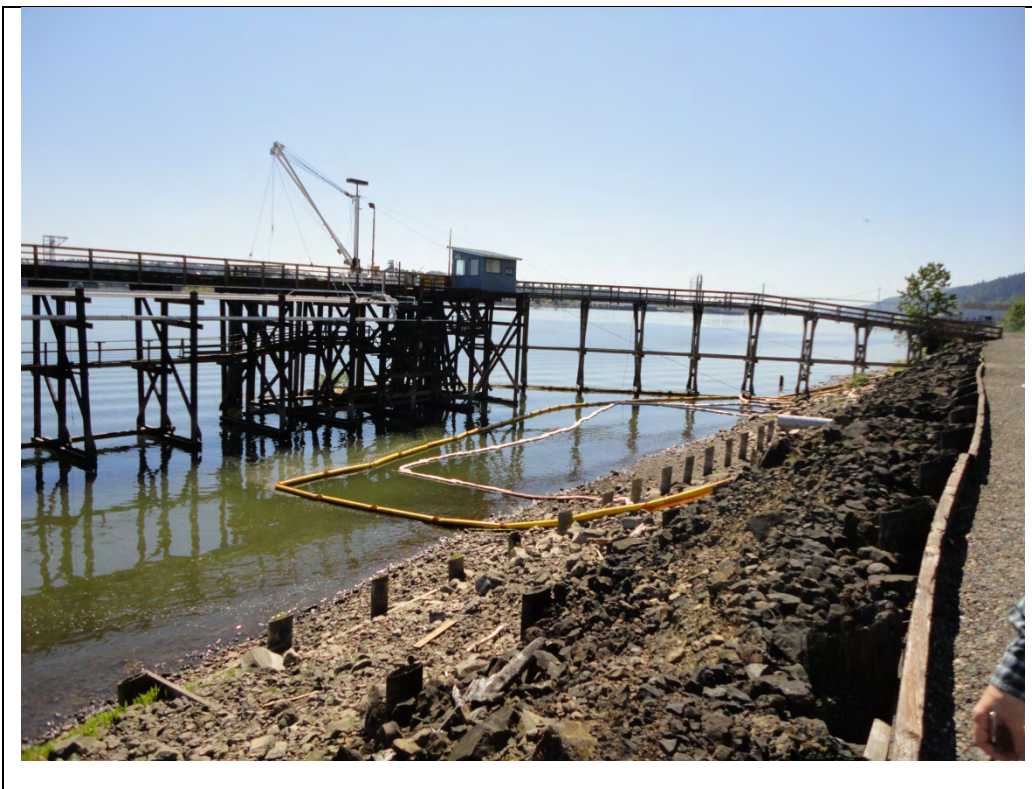
Photograph 2: Dock structure looking up river from approximate Station 5+20

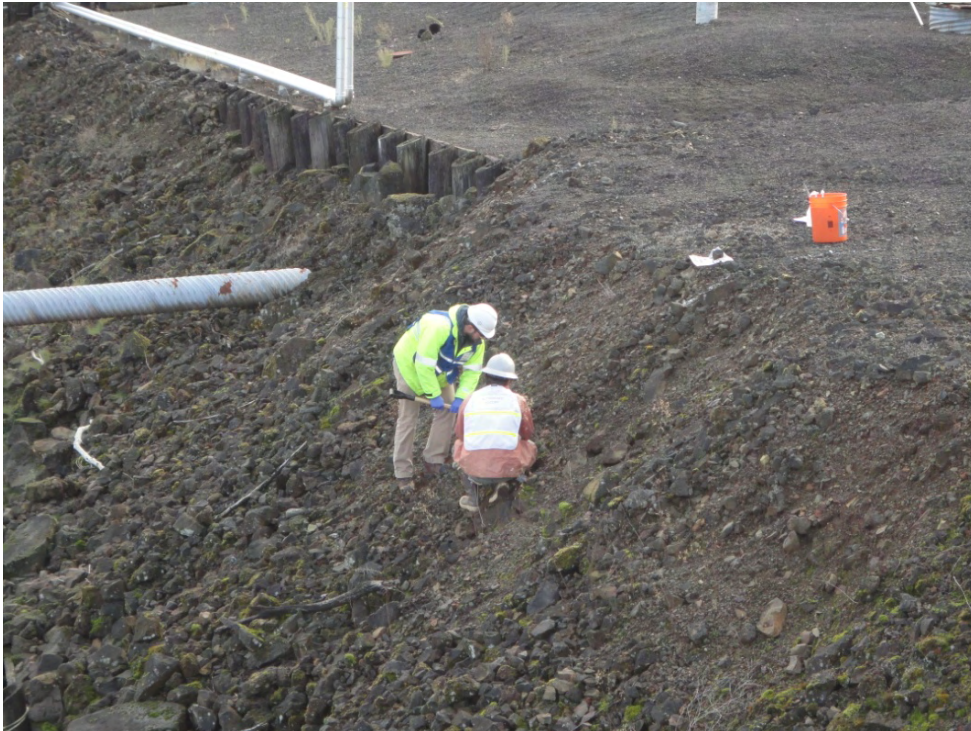
Pictures of this section of the site are presented in Photographs 5 through 8 in Appendix A of this TM. Photograph 8 shows the location where sample G-4-2010 was collected.

Photograph 8: Collecting grab sample for grain size analyses. Station 1+30.

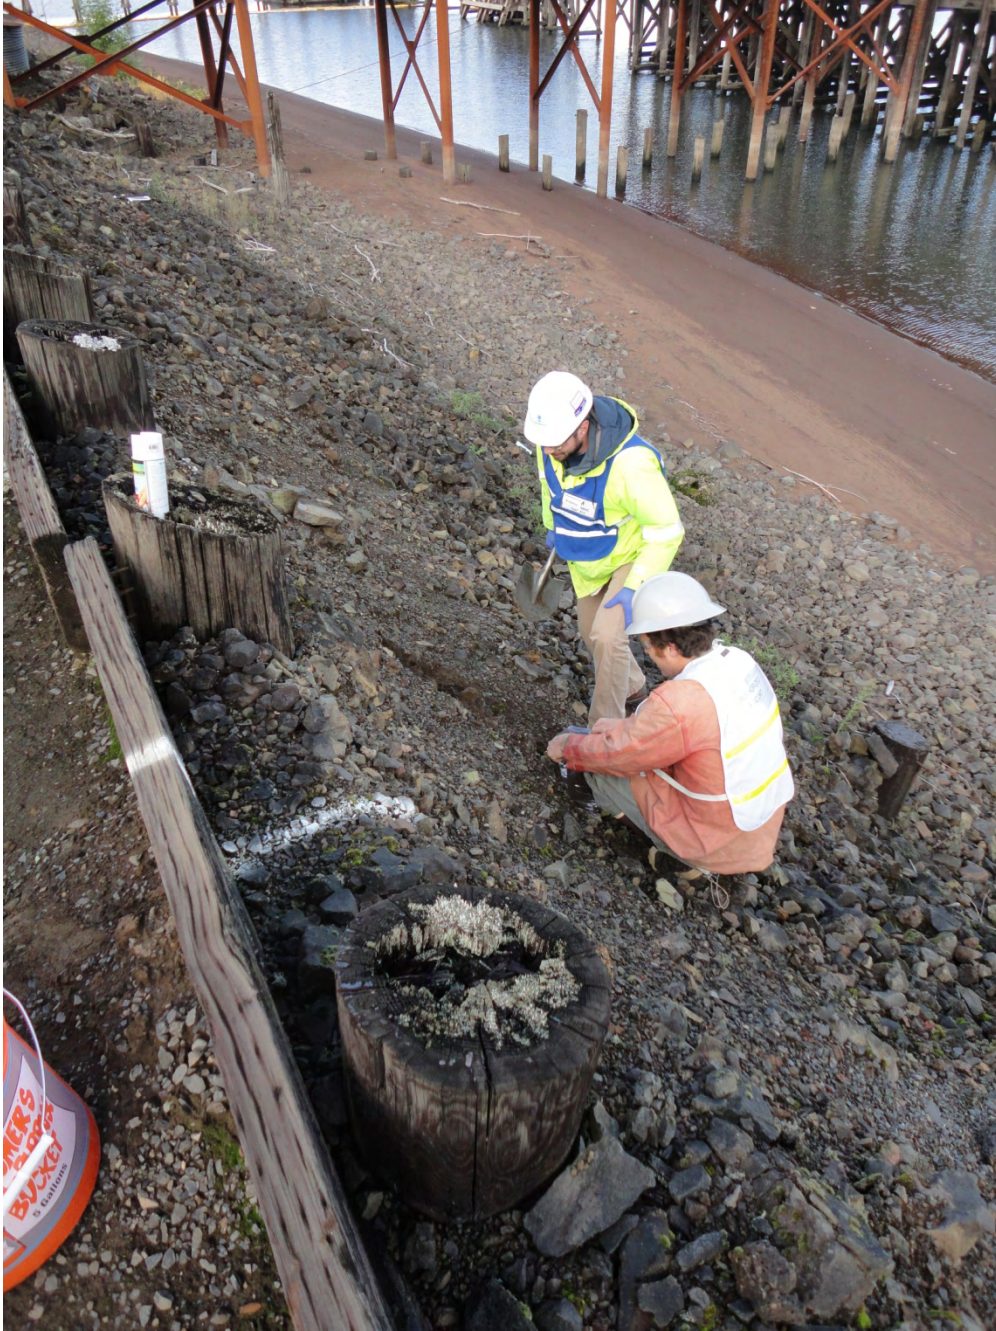
Pictures of this section of the site are presented in Photographs 9 through 11 of Appendix A. Photograph 11 shows the conditions where sample G-3-2010 was collected.

Photograph 11: Collecting grab sample for grain size analysis at Station 4+35.

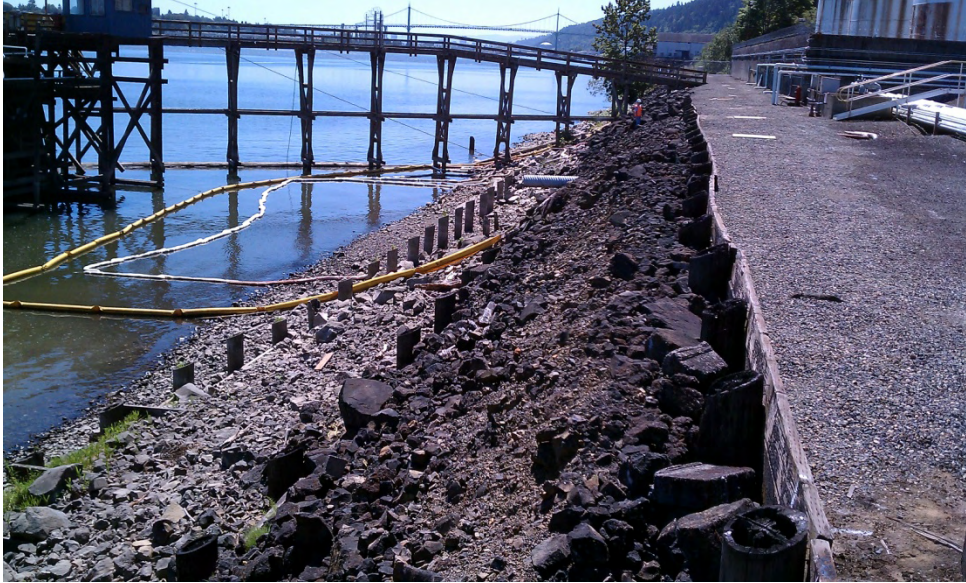
Photograph 12: Looking southwest from top of bank near Station 5+00.

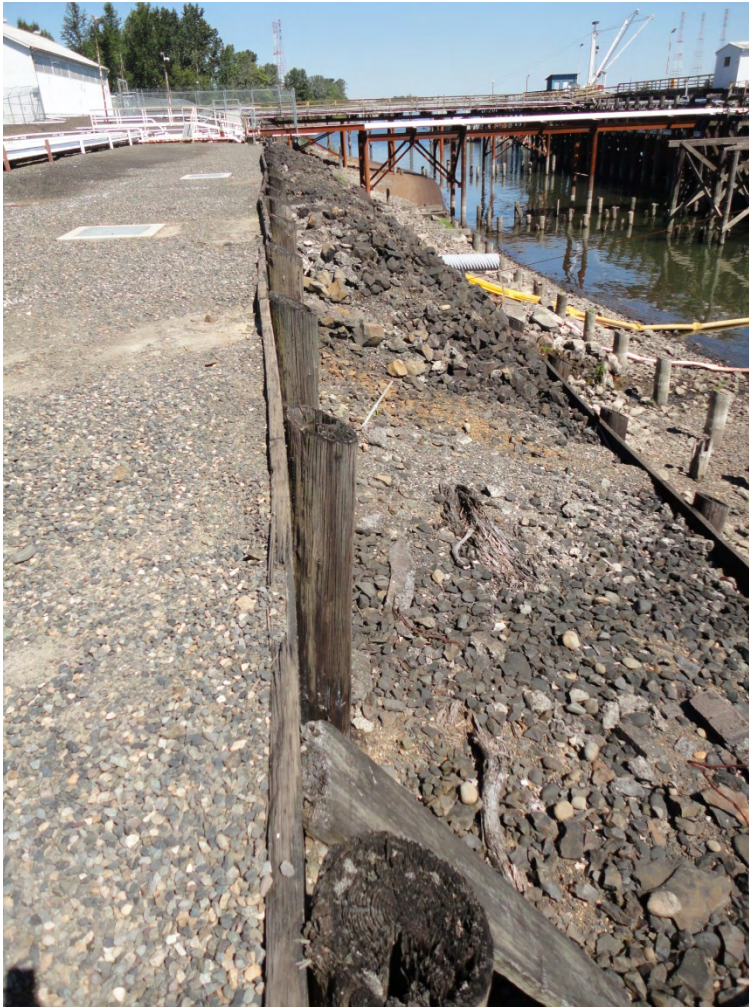
The section of river bank between Stations 4+70 and 6+80 is characterized by more competent sections of timber pile and lagging bulkhead that sometimes retain upslope bank material and extend above the downslope bank materials. Historically, there have been three rows of bulkheads along this section of the river bank. Today, most sections of the three bulkheads are still visible with the condition of the bulkheads improving from the lower row to the upper row. The lower bulkhead is missing the timber lagging between piles in most locations.

Photograph 13: Looking north from top of bank near Station 6+60.

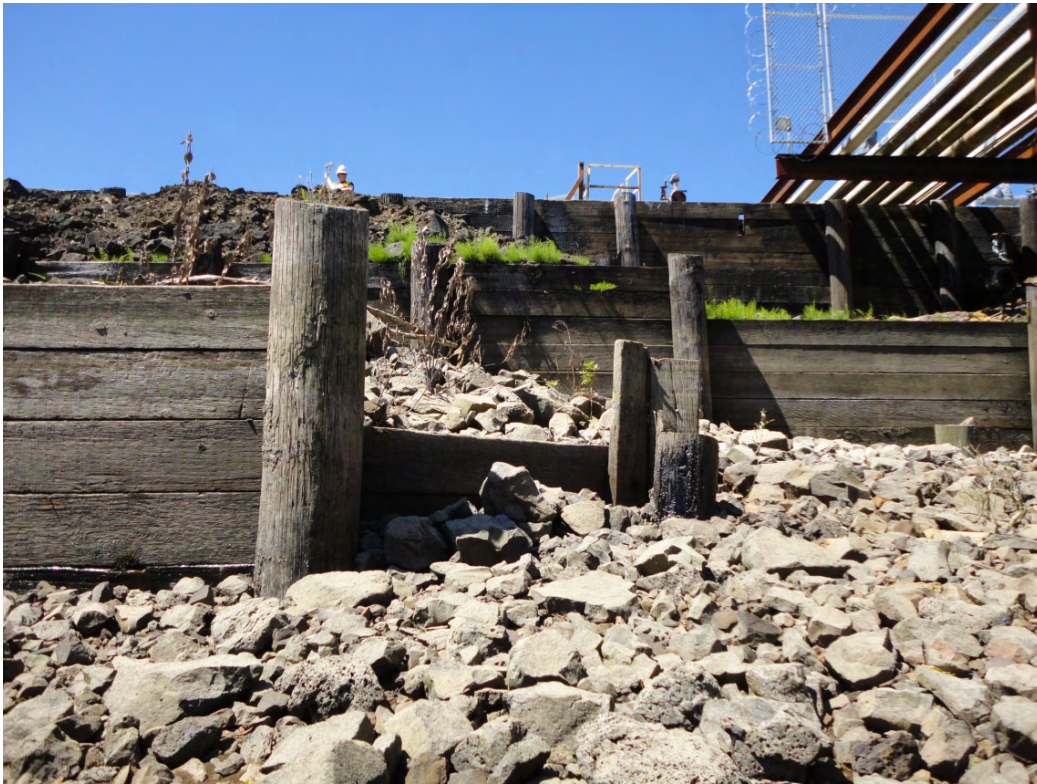
Photograph 14: Station 5+00 Looking up bank from bottom of slope.

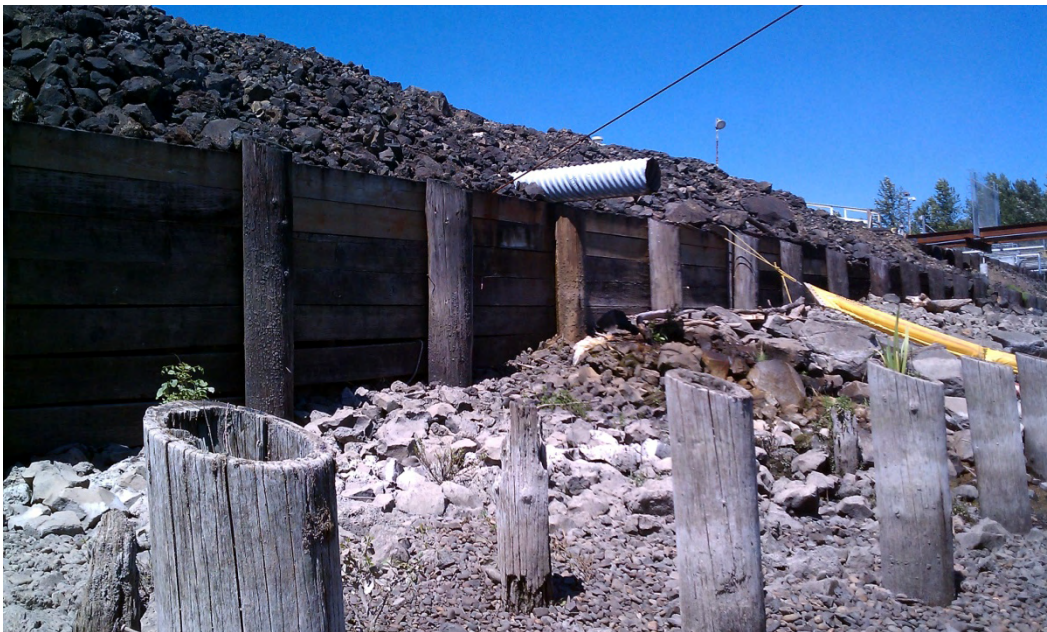
Photograph 15: Station 6+40 Looking northwest from approximate elevation 10 feet.

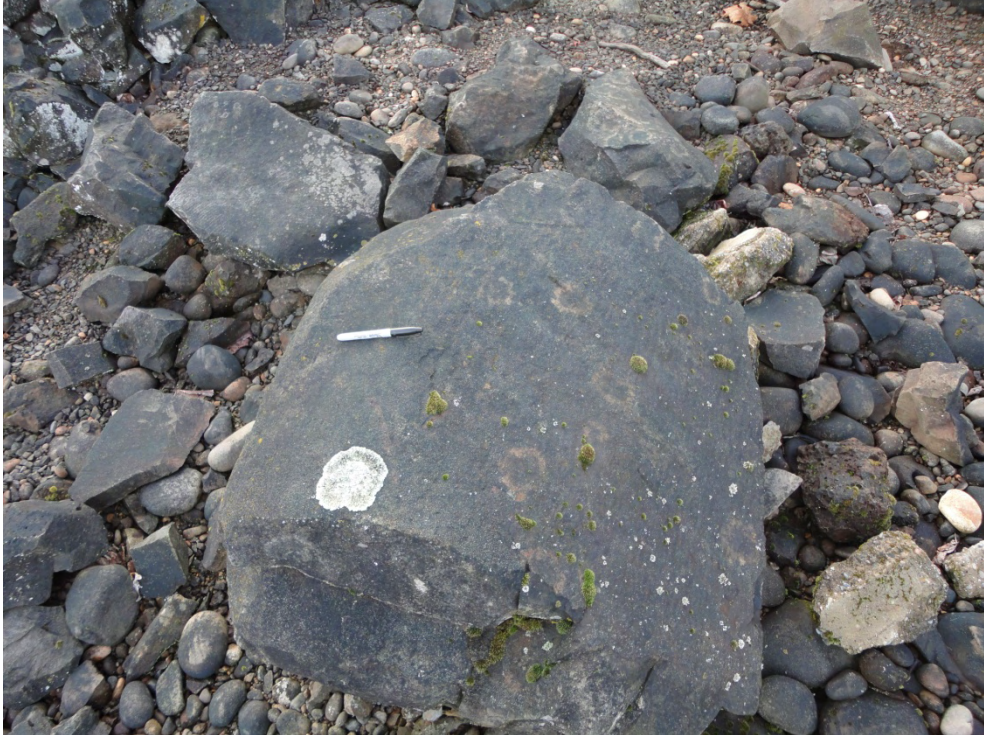
Photograph 16: Surface conditions near Station 6+80 at approximate elevation 22 feet.

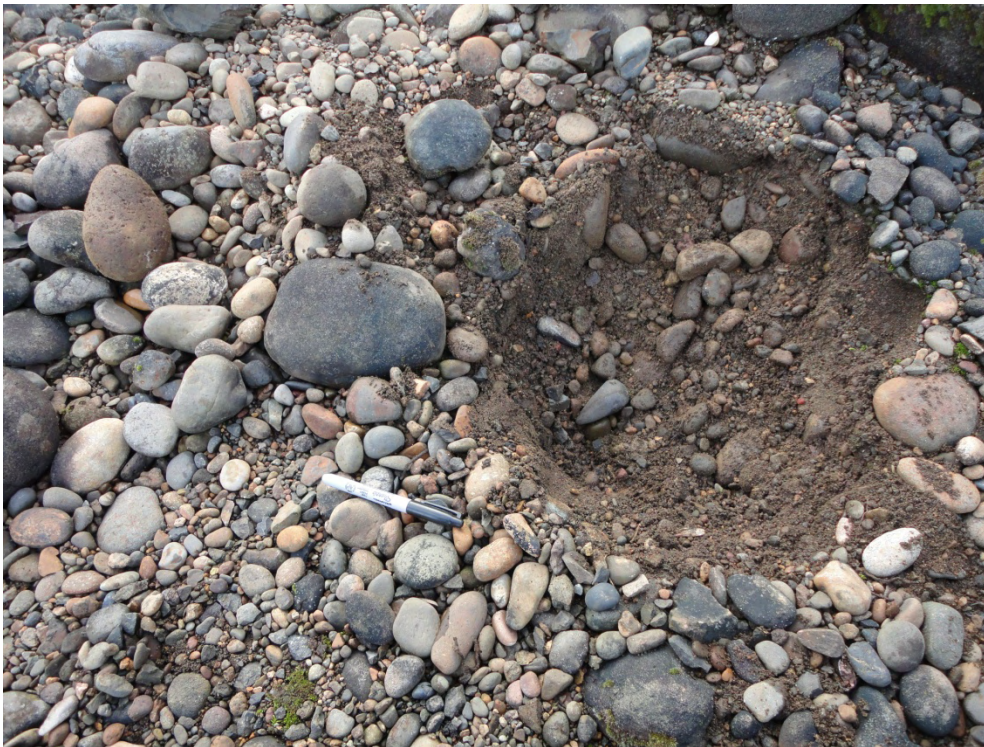
Between Stations 4+70 and 4+90 and Stations 6+20 and 6+80 the upper and middle bulkheads extend above the downslope ground surface and retain bank material upslope of the bulkheads. In these areas the ground surface between the upper and lower bulkheads is relatively flat (about 4H:1V). The ground surface between the middle and upper bulkhead is covered with basalt riprap in most locations. In a few isolated areas the ground surface is covered with rounded river rock with occasional angular basalt. A bulk sample of bank material was collected for grain-size analyses in one of these areas where the rounded rock ranged in size from less than 1 to 6 inches in diameter. The average size of the rounded rock at the surface was about 2 inches. Beneath the surface, the material consisted of a mixture of gravel and sand. The sample, labeled as G-2-2010, was collected at Station 6+45 as shown in Figure 4B.

Pictures of this section of the site are presented in Photographs 13 through 17 in Appendix A. Photograph 17 shows the conditions where sample G-2-2010 was collected.

Photograph 17: Surface conditions at location where grab sample G-2-2010 was collected at Station 6+45.

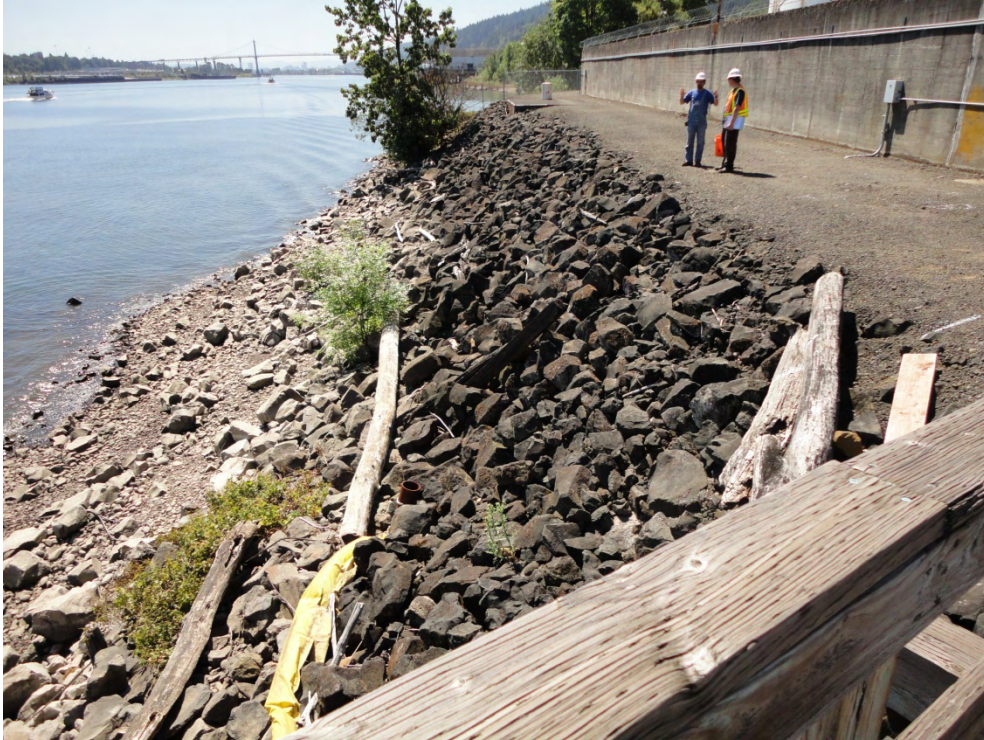
Photograph 18: Surface conditions looking southwest from walkway at Station 7+50.

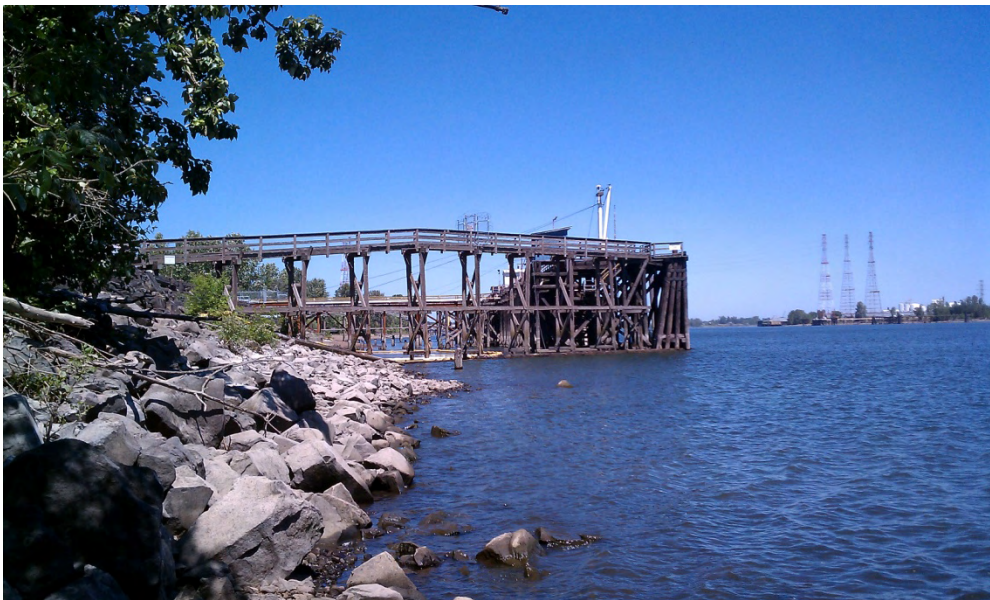
Photograph 19: Surface conditions looking north from edge of water near Station 9+50.

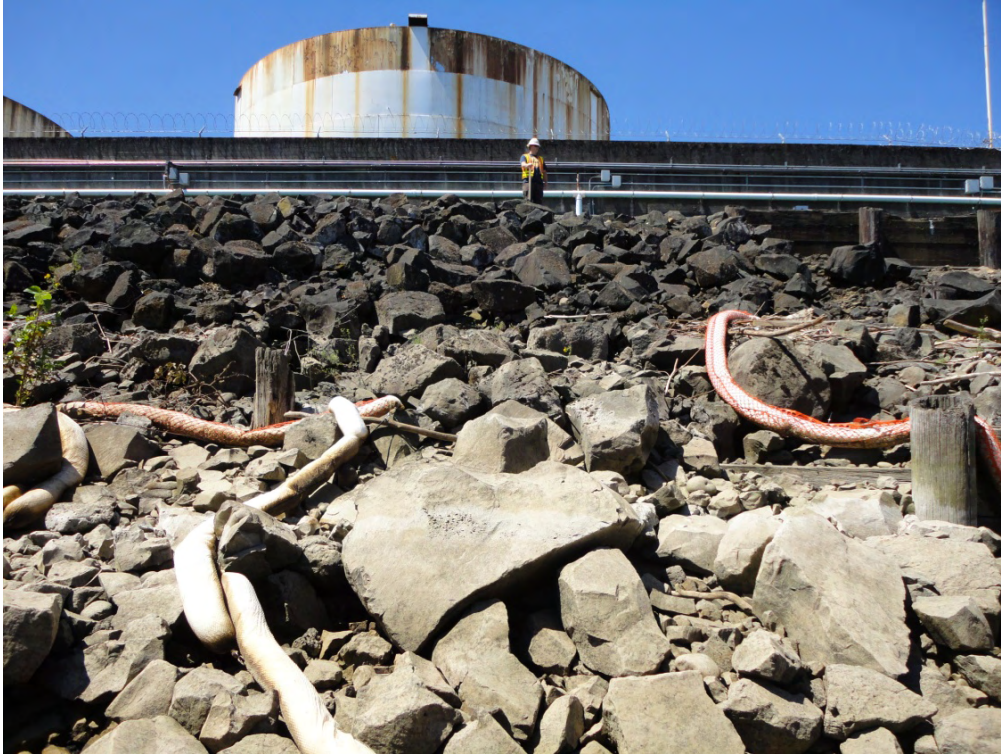
Photograph 20: Station 6+90 Looking up bank from bottom of slope.

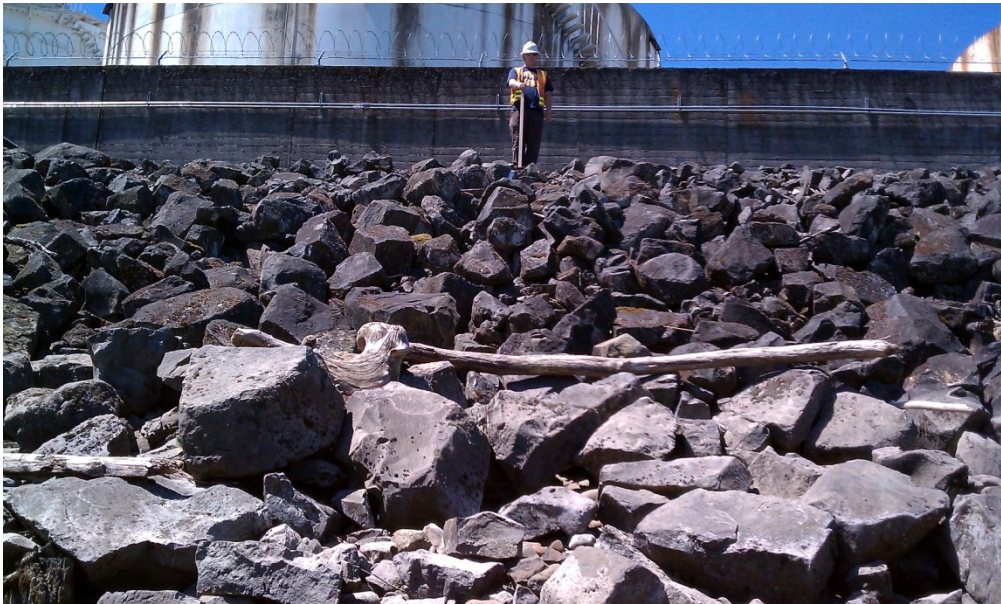
Photograph 21: Station 8+80 Looking up bank from bottom of slope.

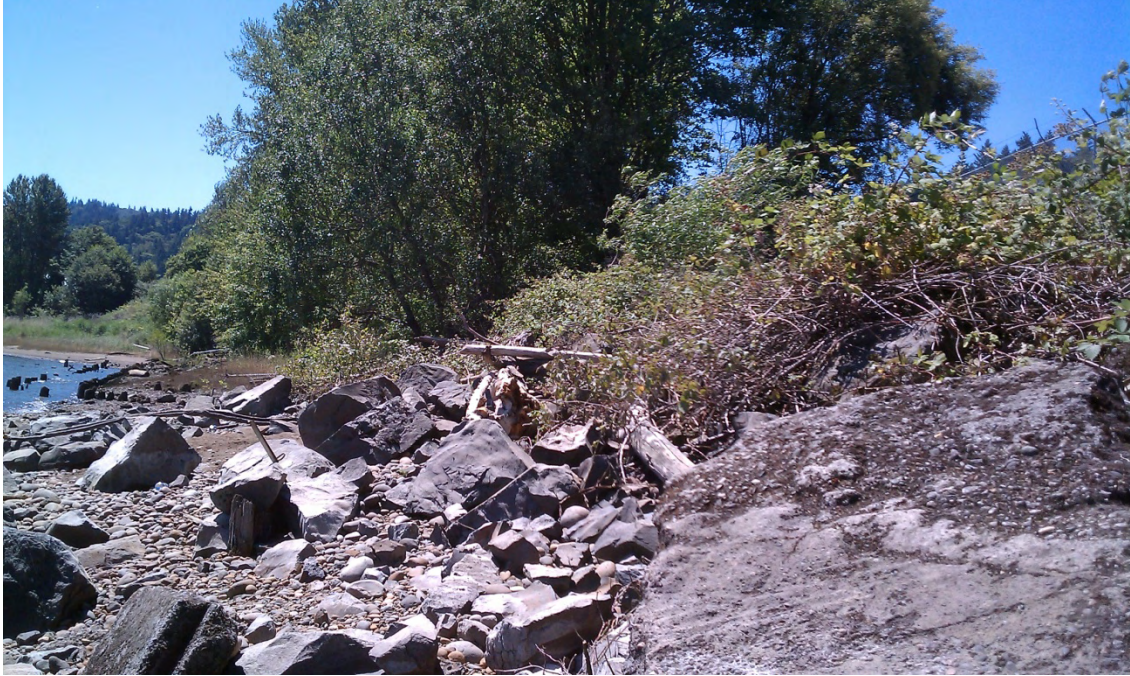
Photograph 24: Station 9+70 Looking south from bottom of slope.
